# Preliminary results for in situ cleaning of B₄C-coated FEL mirrors using oxygen plasma.

Keywords: B<sub>4</sub>C-coated mirrors; carbonaceous contamination stripes; in situ plasma treatment.

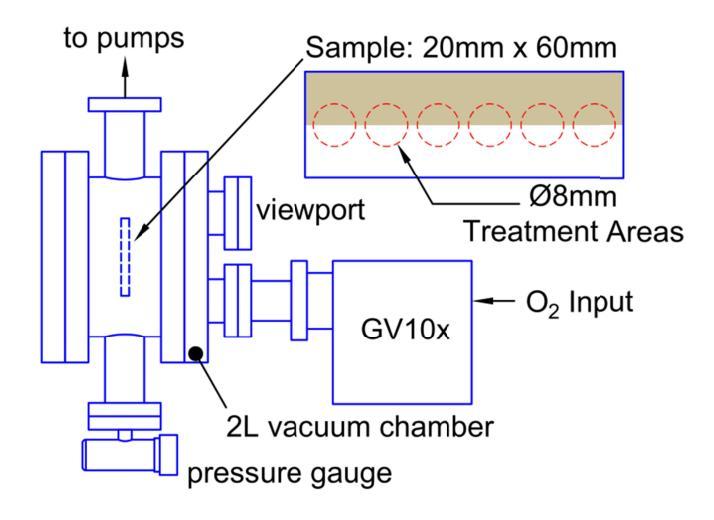
**Figure 1** Schematic illustration of test vacuum system used for initial, preparatory tests, and test sample detail. Plasma gases from the GV10x source enter the vacuum chamber, flow past the sample, and into a turbomolecular pumping station. The sample is a 5 mm thick silicon substrate with 50 nm deposited  $B_4C$ . The upper half of the sample was coated with an additional ~50 nm amorphous carbon.  $\phi 8$  mm treatment areas on the sample could be exposed one at a time.

‡ Estimated from turbomolecular pump pumping speed and conductance of hardware between pump and chamber Under the plasma conditions in Table 1, the amorphous carbon visually disappeared after 15 minutes of treatment. During this time, the presence of the amorphous carbon was easy to see, until the very end, when in <1 minute, the carbon disappeared quite uniformly over the exposed sample region. Treatment was continued, however, for a full hour total.

NewView 8300. Surface roughness was unaffected by oxygen plasma treatment (~5 nm rms, for distortion wavelengths between 6 mm and 4  $\mu$ m.) The removed carbon created a step height of ~55 nm. The boundary between treated and untreated B<sub>4</sub>C was detectable, with a step of at most a few nm, which suggests slight B<sub>4</sub>C etching.

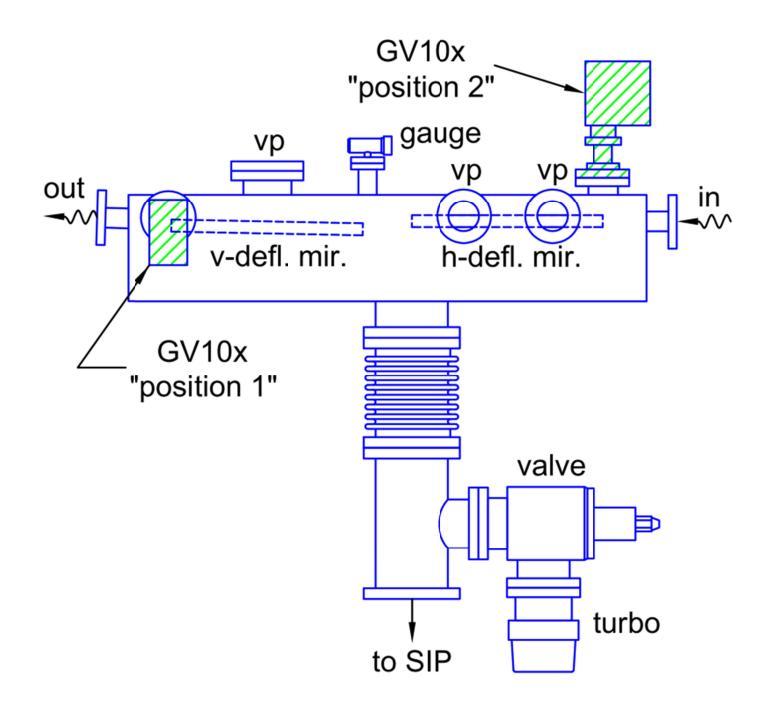
**Figure 2** Schematic illustration of plasma treatment set up for LCLS AMO KB Mirror System. Plasma gas products, produced by the GV10x source, flow between the source and the turbomolecular pump. Treatment was initially made with the source installed in "position 1", and subsequently in "position 2". Viewports associated with each of the KB mirrors allowed visual monitoring of the mirror reflective surface during plasma treatment.

Plasma treatment with the GV10x in "position 1" was visually effective at removing the carbonaceous stripe on the downstream, vertically-deflecting mirror, but essentially ineffective on the upstream, horizontally-deflecting mirror. Only when the GV10x was relocated to "position 2" was effective cleaning of the horizontally-deflecting mirror seen. In addition, treatment in "position 1" was made until a faint stripe was still visible on the vertically-deflecting mirror; this stripe remained after 2.5 hour treatment with the GV10x in "position 2".

Figure 2 schematically illustrates the LCLS AMO KB Mirror System, and details relevant to plasma treatment. Beam line sector valves, located immediately upstream and downstream of the KB system were closed and sealed for plasma treatment. The Convectron gauge was installed to monitor mirror chamber pressure, and chamber pumping was provided by the illustrated turbomolecular pump, throttled by the large adjacent right angle valve (the main sputter ion pump [SIP] was turned "off"). The GV10x plasma source was initially installed near the downstream end of the vertically-deflecting mirror, "position 1". Plasma treatment in this configuration was made for 2 hours, 15 minutes, using the plasma conditions in Table 1. The GV10x was then relocated to the upstream end of the KB mirror chamber, "position 2", as illustrated in Figure 2, and plasma treatment applied for an additional 2 hours, 30 minutes.
