Corrosion of Glass Windows in DIRC PMTs

Abstract

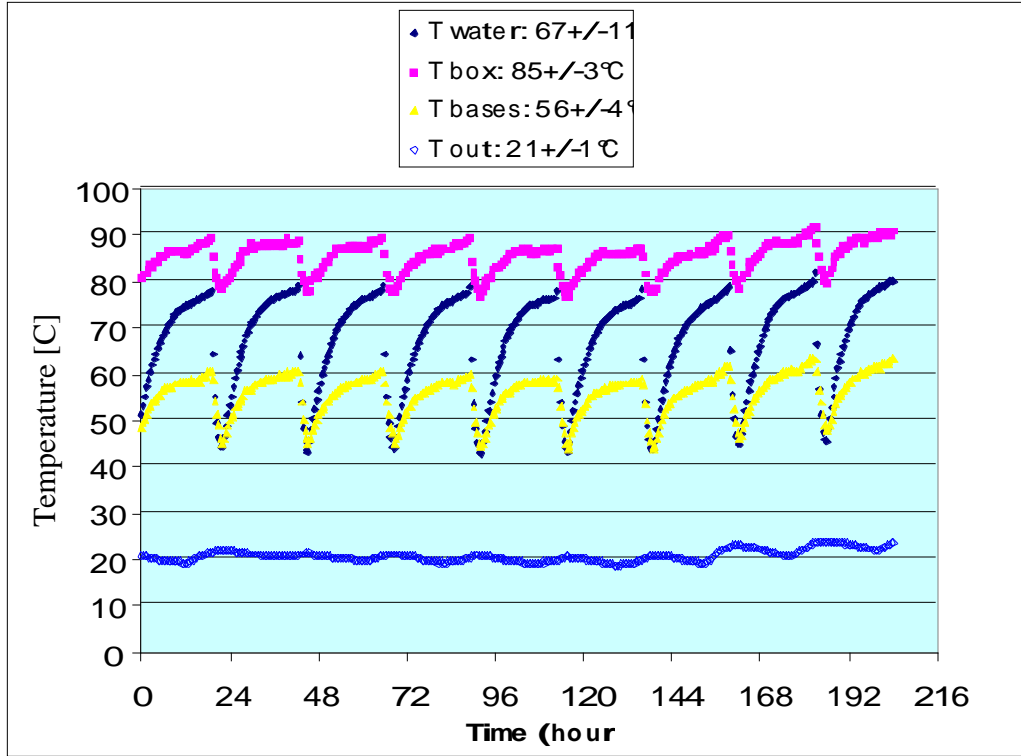
The vessel has been put in a thermostatic box and we periodically measured the temperature at different levels (see Fig. 5). The supply water resistance was $19\text{ M}\Omega$, and $1\text{ M}\Omega$ to $10\text{ M}\Omega$ in the vessel. The pH factor was close to seven after water purification, and about 6-7 in the vessel.

Figure 5. Temperature evolutions between two measurements on the PMTs, the average value of the water temperature has been used to determine the acceleration factor.

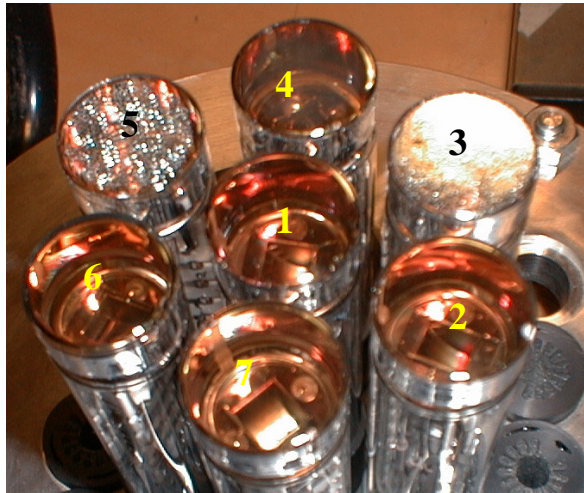
We have taken pictures of PMTs at different stages of the corrosion test - see Figures 7-10. One can see that four clear PMTs become rapidly milky, followed by scratches appearing on the window surfaces. The “frosty” PMTs become progressively frosted, spreading to the edges of the window. One can also see that the characteristic color of the photocathodes disappear on the dead PMTs, as if the surface was wet.

Figure 7. Appearance of seven PMTs, as the beginning of the corrosion test. One can see four “clear” PMTs on the bottom, two “frosty” on each side, and one “milky” at the top right-hand side.

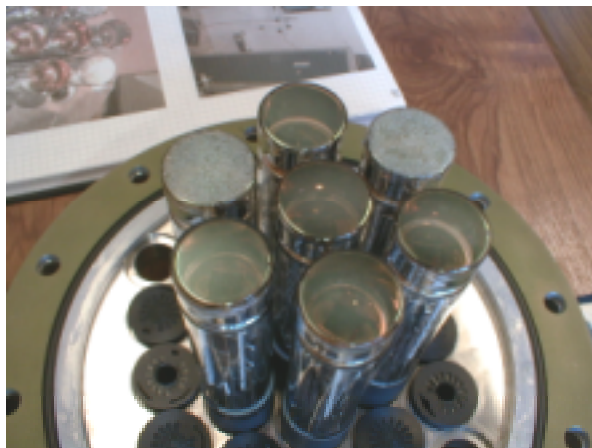
Figure 8. The same PMTs as in Fig. 7, after the first immersion in hot water for up to 40 days (equivalent to 17 months at 28°C). Notice that the four “clear” PMTs shown in Fig. 7 became “milky.”

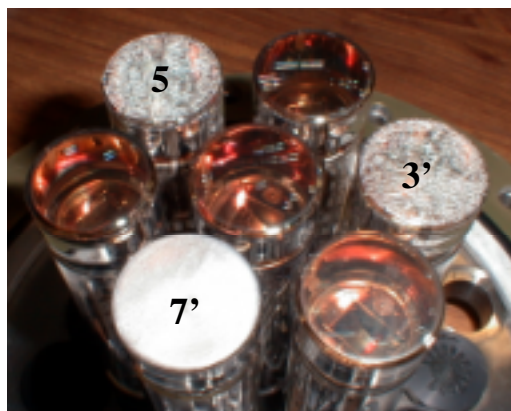
Figure 9. The same PMTs as in Fig. 7, after the second immersion in hot water for 30 days (equivalent to 12 months at 28°C). Scratches appeared on four “milky” PMTs, and edges of the “frosty” PMT # 5 also became “frosty.” It is the first immersion for PMT #3’ and 7’.

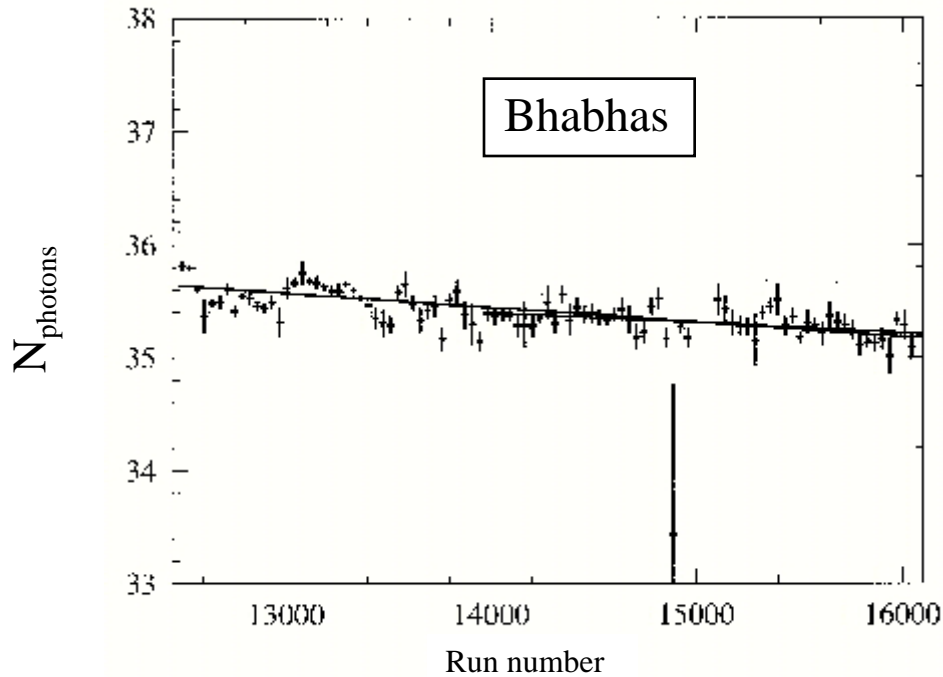
Figure 12. Average number of Cherenkov photons per ring from Bhabha analysis as a function of the BaBar run number [13]. The decline is consistent with 2-3%/year.

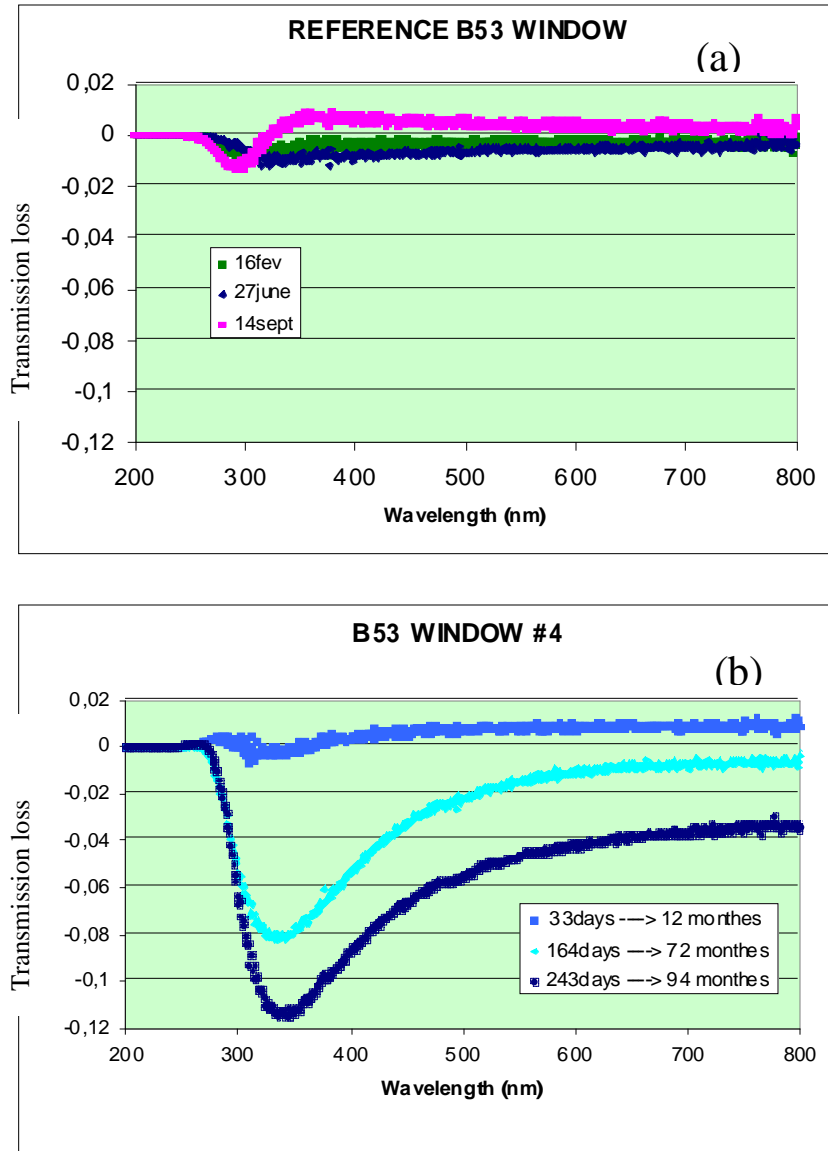
Figure 17 shows the transmission loss as a function of wavelength for a reference glass coupon as well as one of four coupons immersed in hot water at different periods of time. Figure 18 shows the mean transmission loss (averaged over four coupons) at three wavelengths as a function of time. Note that corrosion takes place on both faces, so the transmission loss is greater here than in the SOB. Another important point is that the measurements were not done with water directly coupled to the corroded surface, which would definitely improve the transmission, even though the surface is visibly corroded. In that sense, this is a less important result, which is not directly applicable to the DIRC analysis. It only indicates that the glass surface is indeed corroded.

Figure 17. Transmission loss (relative to the initial transmission) for (a) the reference B53 window, and (b) for one coupon immersed in hot water at different periods.

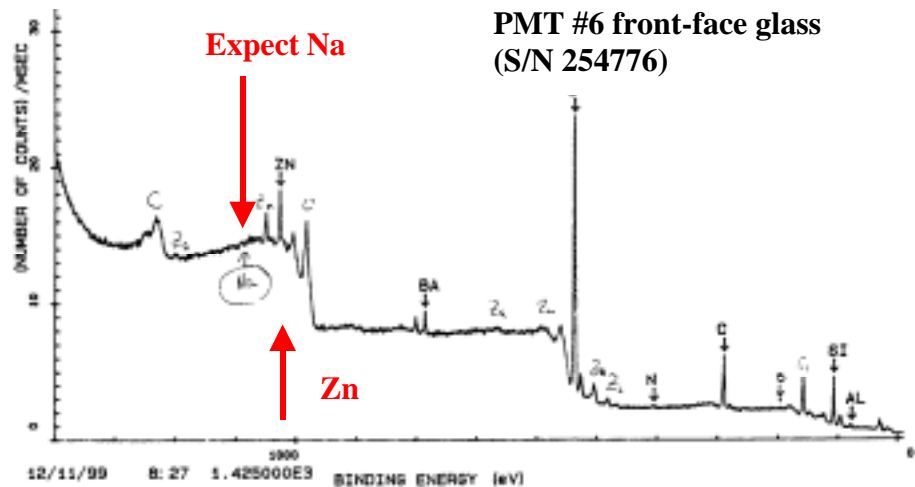
Figure 26. ESCA analysis of front-face glass of PMT #6 (S/N 254776), which was judged as “milky,” and removed from the SOB vessel during the October 1999 shutdown. Zn is clearly detected, which is taken as a proof that the glass was indeed B53 glass. This result is consistent with the “milky” appearance; however, there is no sign of Na.

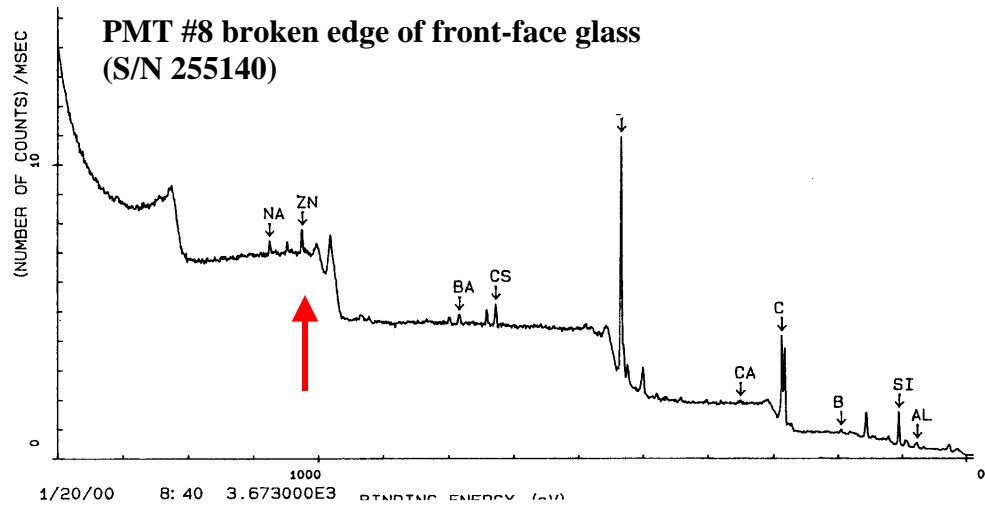
Figure 28. ESCA side analysis of the broken edge of the front face glass of PMT #8 (S/N 255140), which was judged as “milky,” and removed from the SOB vessel during the October 1999 shutdown. Both elements, Zn and Na, are clearly detected in the volume of the front glass. This means that the glass is B53-type glass, which meets the required glass type.

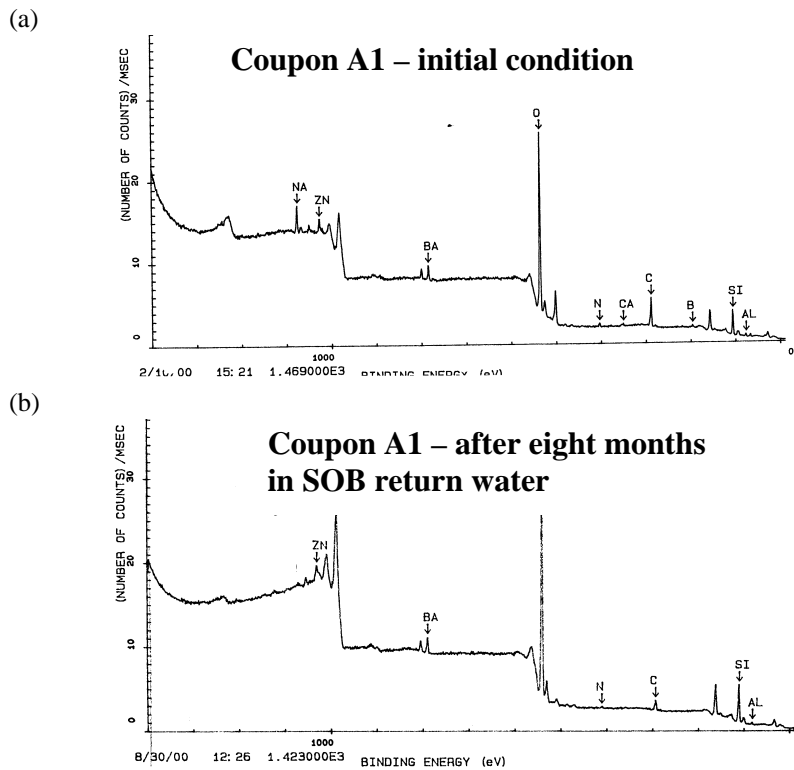
Fig. 32, which is sensitive up to the first $\sim 50\text{\AA}$. The glass coupons appeared clear, as judged by visual inspection, when removed from the water. However, we have observed crazing when the coupons were placed in vacuum during surface analysis, as shown in Fig. 33. The crazing affected coupons independently, whether they were pumped on or not during the test, and appeared obvious to the naked eye. One could qualify it as “milky” rather than “frosty” surface from the point of view of our earlier discussions. The flakes appear to be very shallow and few microns thick. In other words, a PMT would operate normally, and with water coupling, we would not see any deterioration of efficiency. This result would be consistent with the ETL manufacturer’s finding that it is Zn, which prevents “frosting” development in this particular glass material. We still observe Na depletion and the front window turns “milky;” however, these corrosion effects are much smaller, and DIRC would operate well over the next ten years.

Figure 32. (a) ESCA analysis of the PMT front glass coupon A1, prior to the water test. Both elements, Zn and Na, are clearly detected. This proves that this particular glass has traces of Zn present. (b) The same coupon after eight months in the SOB water return. The Na line is completely missing. The Zn line is still present.
