SLAC-PUB-8448
May 2000

Some Solved Problems with the SLAC PEP-II B-Factory Beam-Position Monitor System

Ronald G. Johnson and Stephen R. Smith

Presented at 9th Beam Instrumentation Workshop, 5/8/2000—5/11/2000,
Cambridge, MA, USA

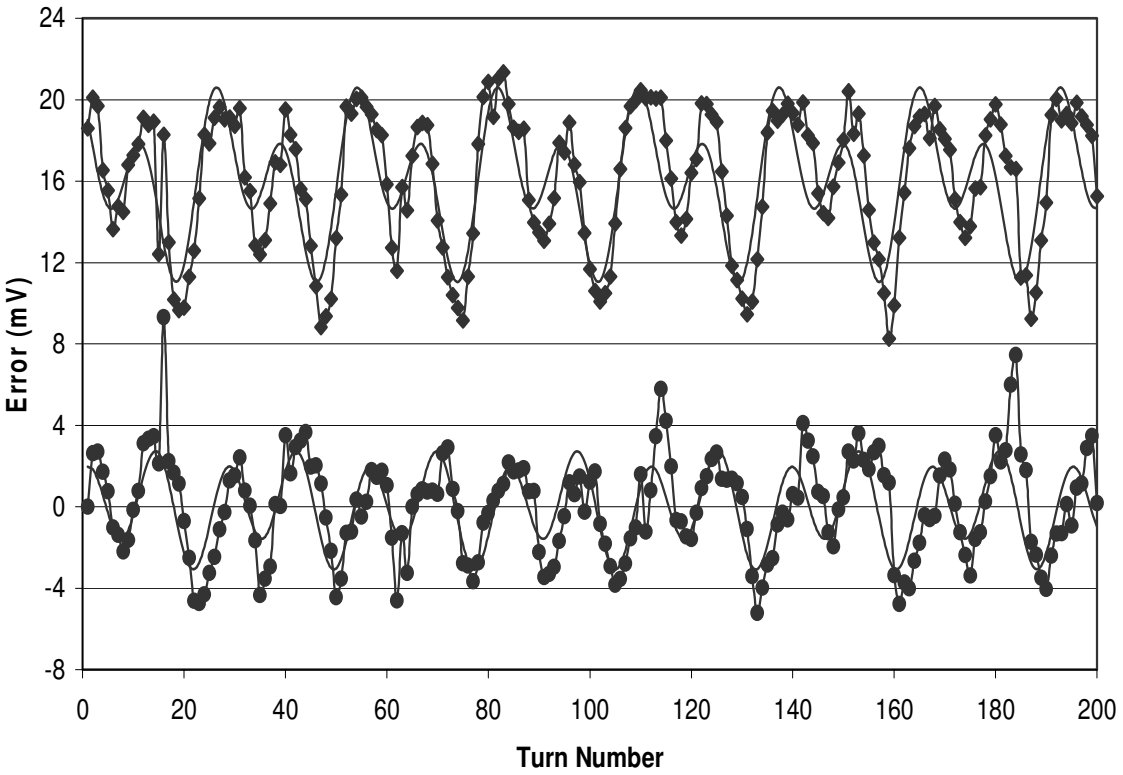
Early in the commissioning of the HER, the first and perhaps most annoying of our problems appeared. The beam position as reported by the BPMs oscillated at a rate of 21 Hz with an amplitude of about 50 μm. This so called 21-Hz problem was soon traced to errors in the calibration parameters. For each channel in the RInQ there are four parameters determined through a calibration, i.e., a least-squares fit to data obtained from signals produced by the calibrator oscillator. The parameters are the pedestals for I and Q and the ratio and phase error between I and Q. The calibration also determines the ratio of the positive and negative channels. Errors in these parameters lead to oscillations of a position measurement at harmonics of the baseband frequency (the difference between the measurement and local oscillator frequencies). Note: the size of the errors in these parameters is generally less than 0.5%.

Eventually it was realized that in a position measurement the error vector for each RInQ channel contains the second order information necessary to correct the calibration parameters. In particular a fit to the error vectors using sine and cosine functions of the fundamental and first harmonic provide corrections to all the calibration parameters, i.e.,

The coefficient of the sin2x term (a_3) is a correction to the I and Q phase error. Similarly the a_1 and a_2 terms are corrections to the pedestals and a_4 is the correction to the I and Q ratio.

FIGURE 2. ΔV+ (top) and ΔV- (bottom) from a typical RInQ module. The smooth curves are the fits. Note: ΔV+ has been offset by 16 mV.

In practice the beam itself becomes the source to refine the calibration for the RInQ modules. When running with stable beam, a request is issued to the modules to refine the calibration. Each module takes 1024-turn data and fits the position information with equation (1). The parameters of the fit are used to correct the calibration parameters. Typically this procedure improves the resolution by a factor of two to three.

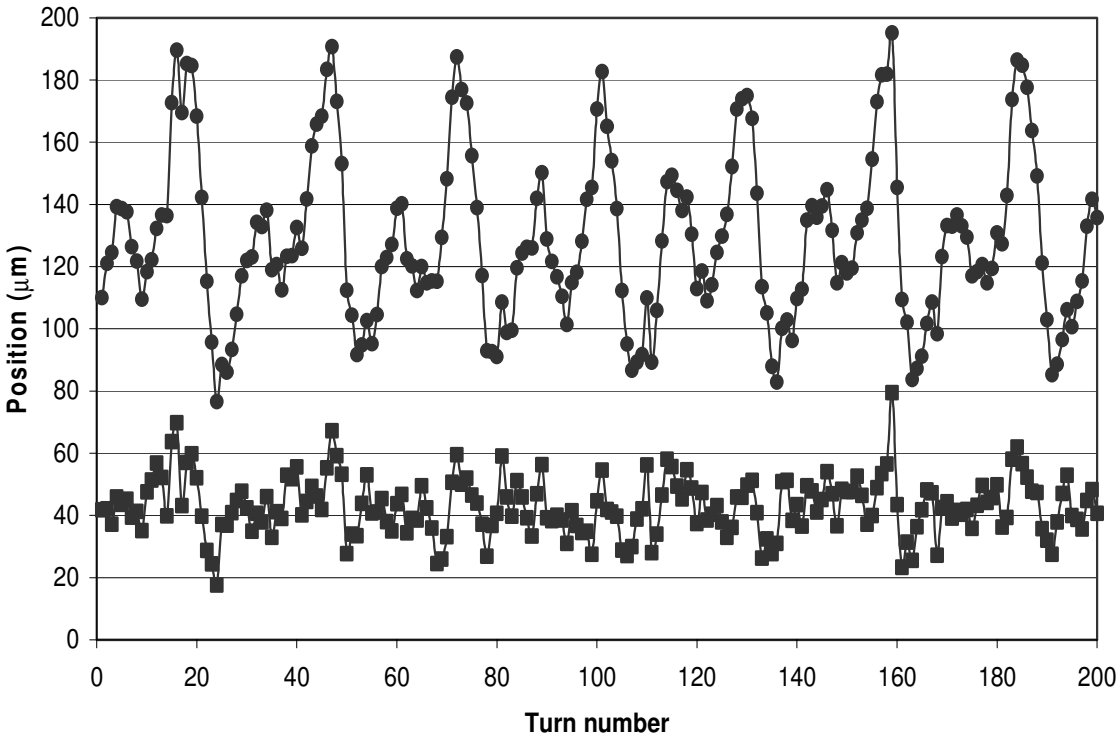
It is apparent in Figure 3 that there are higher harmonics in the data. This fact is even clearer when a Fourier transform is performed. We believe that the higher

harmonics are due to non-linearities in the system. However, we have been unable to parameterize them such that they can be predicted and thus removed.

FIGURE 3. Position measurement from a typical RInQ module before and after calibration refinement. Note: the before refinement data has been offset by 80 μm for clarity.

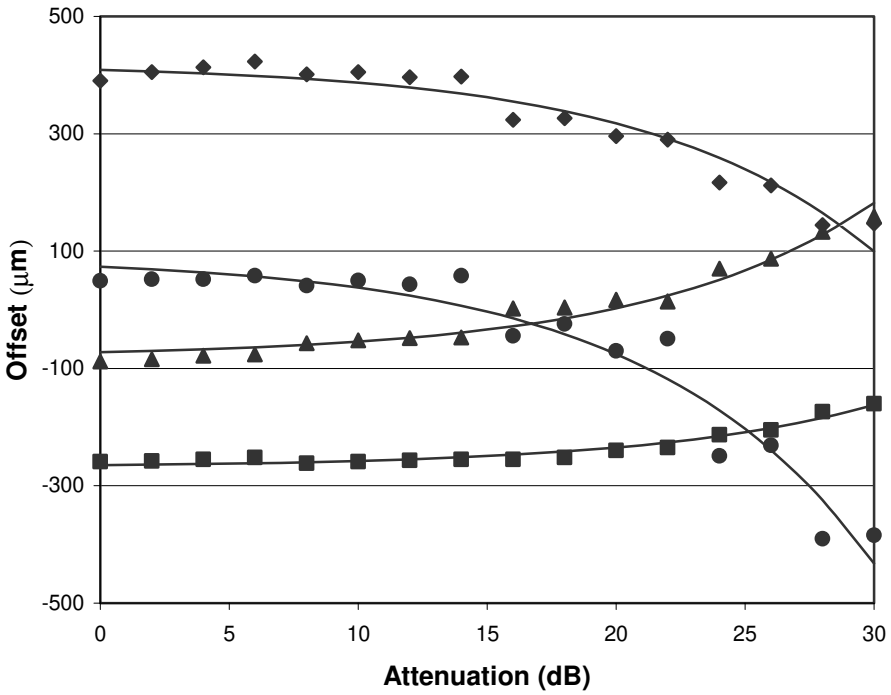
The tests for attenuator hardware problems revealed a slow change of offset as a function of attenuation. It was apparent that a small fraction of the calibrator signal was coupled to each channel after the attenuator. As the channel attenuation is increased the calibrator signal amplitude is increased to produce sufficient signal for the calibration. Depending on which coupling is larger the offset is driven in that

direction. For all channels except LA the direction appears to be random. For LA the offset increases in the negative direction.

and A is the channel attenuation in dB. Offsets for a typical RInQ module are shown in Figure 4. The smooth lines in this figure are fits using equation (6).

FIGURE 4. Offset vs attenuation for a typical RInQ module. LA – circles, HA – diamonds, LB – squares, and HB – triangles. The smooth curves are the fits to the data.

Since these fits work so well, no attempt was made to fix the problem in hardware, e.g., isolating the calibrator traces. Instead the on-line code and database were modified to calculate the offset at each channel attenuation using equation (6). All RInQ modules were tested to measure the slope and intercept of the offsets.
