SLAC–PUB–9808
May 2003

Use of Acoustic Emission to Diagnose Breakdown in Accelerator RF Structures [*]

J. Nelson, M. Ross, J. Frisch, F. Le Pimpec, K. Jobe, D. McCormick, T. Smith
Stanford Linear Accelerator Center, Stanford University, Stanford CA 94309

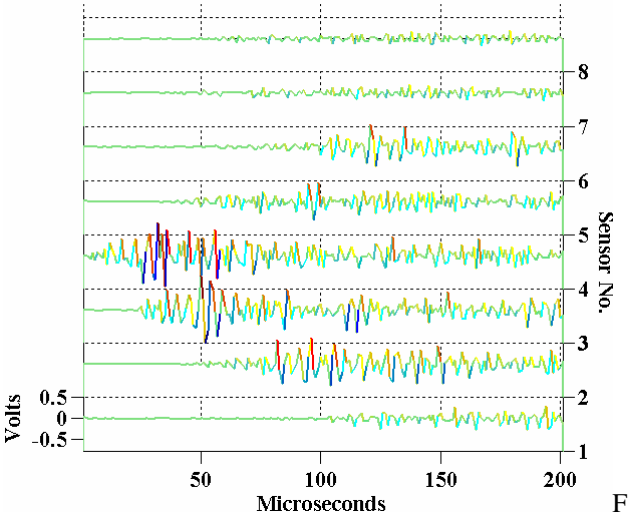
Figure 1: Recorded voltage signals from TTF gun acoustic sensors from a single breakdown event.

In Fig. 1, the breakdown signals that are largest and arrive earliest (sensors 3 and 4) are around the waveguide coupler iris. Those that are small and arrive later (sensors 7 and 8) are attached to the gun's cavity coupler cell and close to the cathode, respectively. The shapes of the envelopes of the signals are not understood.

For the TTF L-band gun the breakdowns were isolated to the input waveguide coupling iris, not the cathode as originally suspected. Typical signals from the 3 sensors on this iris are shown in figure 1 as signals 3, 4, and 5. Using the t_0 technique and given the distance between the sensors and the potential breakdown sources, one can pinpoint the breakdown location between sensors 4 and 5, as well as calculate the speed of the signal's propagation: 3520 ± 810 m/s. This speed is between the p and s wave speeds. The sensors probably see both waves with differing sensitivities.

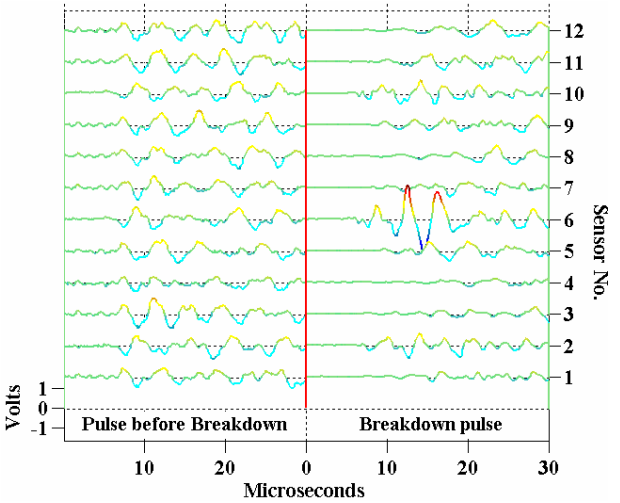
Figure 2 shows two consecutive pulses for 12 sensors (3 cells, 4 sensors per cell). Sensor 6 shows the largest signal, about 30 times larger than the non-breakdown pulse. Adjacent sensors 2 and 10 have relatively small signals, indicating very localized energy deposition at sensor 6.

Figure 2: Two consecutive RF pulses in NLCTA. The amplitude of the non-breakdown pulse has been increased 10x.

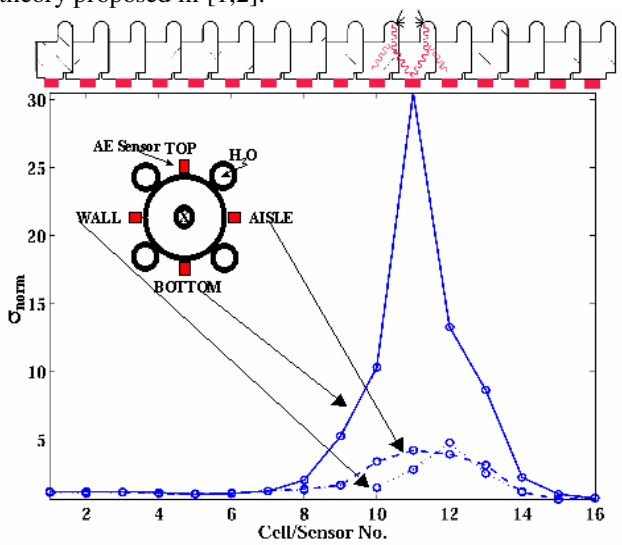
This selected 15 of the 400 events in the body of the structure. Figure 3 shows a typical event of this type.

This figure shows that the sensors' resolution is less than the distance between the sensors around the cell and about equal to the cell spacing. Using the t_0 technique, we found that the signals from sensors i±1 arrive at the same time, approximately 1 μs later than the signal from

sensor *i*. Given that the sensors are mounted between the irises, the breakdown can only be coming from both irises, not just one. This result is consistent with the theory proposed in [1,2].

Figure 3: σ_{norm} for a typical multiple-iris event. The solid line connects data from 16 sensors, one per cell, in a row. Along the top is a schematic of the structure, showing the placement of the sensors between the irises as well as a possible path for the sound from the breakdown to travel. The inset shows the sensors mounted around a cell. Of note is the vertical scale: more than 30 times the energy deposited on a non-breakdown pulse is seen by one sensor.

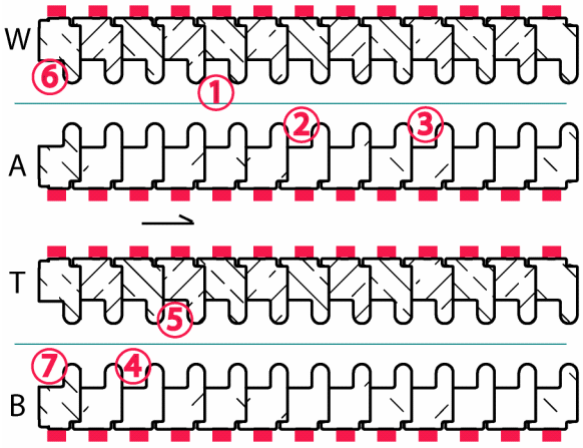
Another phenomenon seen during processing of the X-band structures in NLCTA is the so-called spitfest –when breakdowns are rare, but clustered in time. For example, there will be no breakdowns for more than 30 minutes, followed by many breakdowns in quick succession, less than two minutes apart. Some of these breakdowns occur at very low voltage. From a two week, steady-state running period with 288 breakdowns, 141 happened within two minutes of the previous event in 62 spitfest groups. Figure 4 below shows the locations of seven breakdowns that happened in one spitfest sequence.

This figure shows that subsequent breakdowns aren't confined to the same location as the first breakdown and actually vary their locations by more than just a few cells. This is inconsistent with the assumption that subsequent breakdowns happen near the surface damage caused by the first breakdown.

Figure 4: Sketch of a section of a 60-cell X-band structure showing the location of a series of breakdowns in a spitfest. The rows correspond to the rows of sensors on the structure: on the wall, aisle, top and bottom sides.
