Diagnoses and Controls of Single e- Pulse Extraction at LCLS-I for the ESTB Program*

J.C. Sheppard[†], T. Beukers, W.S. Colocho, F.J. Decker, A.A. Lutman, B.D. McKee, T.J. Smith, M.K. Sullivan, SLAC National Accelerator Laboratory, Menlo Park, CA

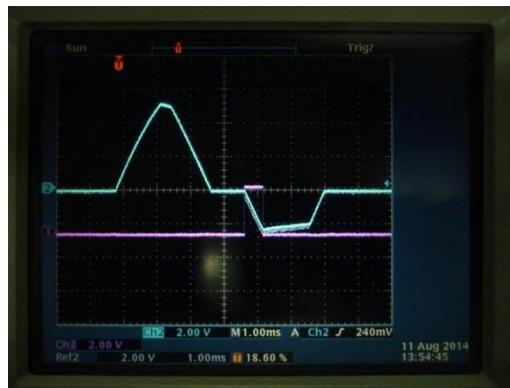
Figure 1a: Pulse kicker current waveform

and the third pulsed magnet is powered by a second power supply (a fourth pulsed magnet is being prepared for installation in spring of 2017 and will be powered in series with the existing third magnet). At maximum current, the three magnets are sufficient for extraction of beams with energies up to 16.5 GeV. The pulser also generates a controllable reverse current pulse 1 ms after the primary pulse. This back swing pulse is used in the cancellation of eddy currents.

Each magnet consists of a pair of 1-m long, air core coils. Initially the coils were supported in an aluminum frame and mounted on an Al baseplate. The baseplate was supported in the accelerator housing on a steel girder. After the problems of the eddy currents were identified, 80/20 T-slotTM Al frame members [4] and Al baseplate were replaced with G10 pieces to break up eddy current flow paths and to remove the baseplate “mirror.” The effect was to reduce the eddy current fields that affected subsequent bunches by a factor of about 10 from about 10 μm to about 1 μm . Figures 1 a,b,c show the pulsed current waveform; the original magnet with Al frame and baseplate; and the G10 modified magnet.

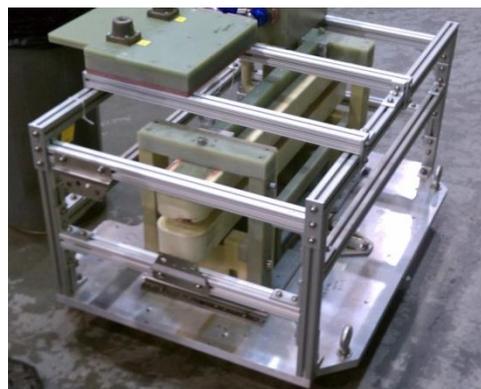
Figure 1b: Original Al frame and baseplate kicker magnet

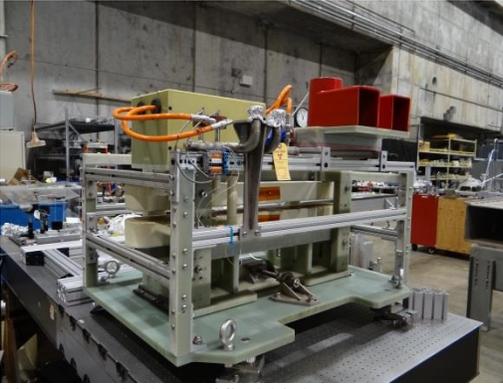
Figure 1c: G10 modified kicker magnet.

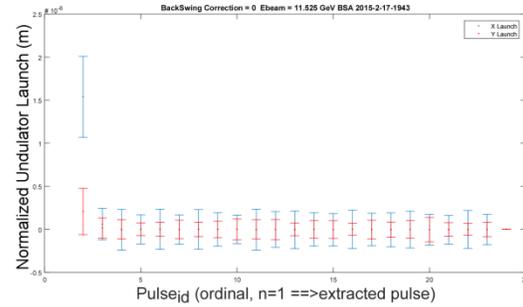
Figure 2a: Normalized undulator launch without post kicker correction.

direction of the residual kick does not vary. This scheme was initially installed as a test and found to work well and was subsequently extended to being pulsed on the $n+1$ and $n+2$ pulses. Figures 2 a,b show the beam displacement without and with correction. This data was collecting using the Beam Synchronous Acquisition utility [7] with records data from 1149 monitors for up to 2800 sequential beam pulses. The 2800 beam pulses are averaged in 24 bins corresponding to 5 Hz pulse extraction from a beam rate of 120 Hz. Figures 3 a,b show the corrector current waveform and the installed corrector pair.

In figures 2a and 2b, the horizontal axis is the ordinal Pulse_{id} wherein $n=1$ is the extracted pulse; the vertical axis is the normalized undulator launch.

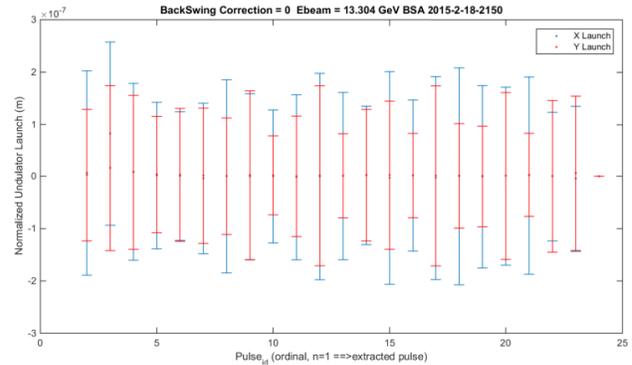
Figure 2b: Normalized undulator launch with post kicker correction.

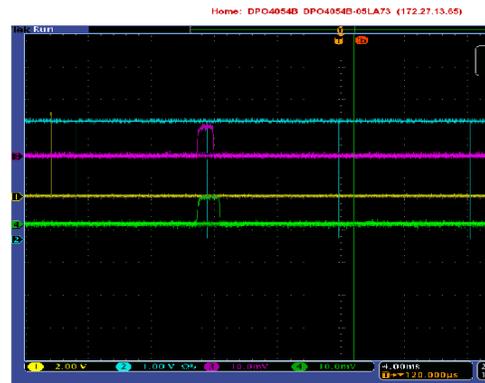
Figure 3a: Post kicker current waveform; note toroid calibration = 100A/V.

An air core pulsed magnet was designed and installed to compensate to the residual kick at the $n+1$ pulse. The magnet is an X-Y set of nested PEP-I corrector coils (24 turns, 20.3 cm long, 15.2 cm wide, 12.7 cm separation 2.1×10^{-4} kGm/A) A unipolar power supply is used since the

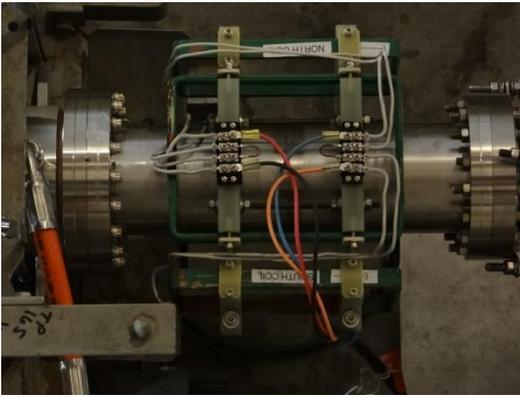
Figure 3b: Post kicker corrector coils installed in the SLAC BSY.

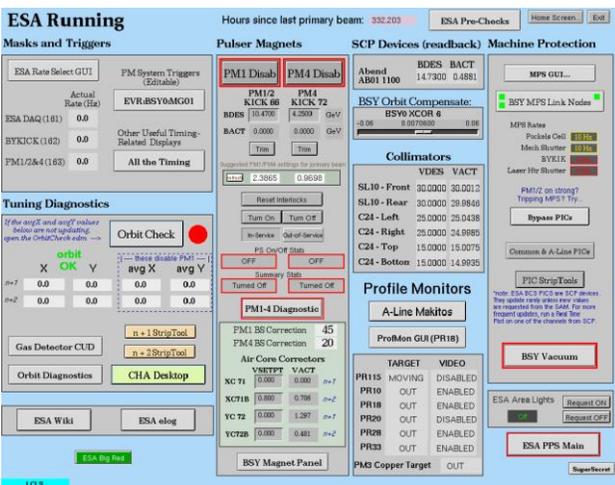
Figure 4a: Control system operator interface for A-Line extraction.

An online, live time launch monitor system was developed to ensure that the kicker compensation was properly set up and did not drift off. Called Tuning Diagnostics, this program calculated the launch into the undulator on a pulse-by-pulse basis. To protect against flyers, each new orbit was added with a damping factor to a running average of the previously measured orbit. This averaging effectively reduces the bandwidth of the measured launches. Alarm and abort set points on the measured launch error are used to (1) warn an Operator that the launch error exceeds a warning threshold and (2) shuts off pulse extraction if the launch error exceeds the acceptable tolerance. Shut off requires Operator intervention to manual restart pulse extraction after having diagnosed and remedied the offend cause of the launch error. Figure 4 a,b shows the Control System displays used to set up, monitor, and control A-Line extraction. An extensive Operations procedure has been developed. This procedure

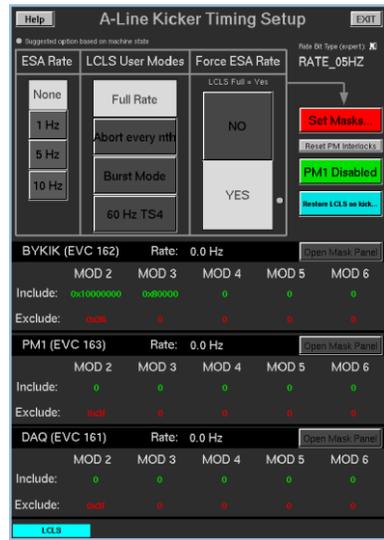
Figure 4b: Time system interface panel.

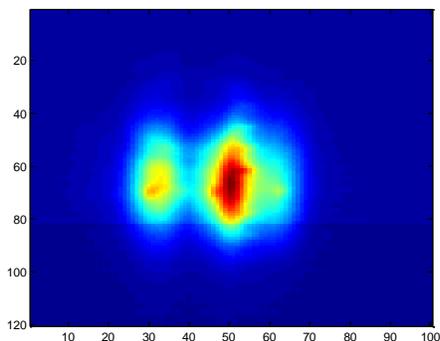
Figure 5a: 7.87 keV xray spot on XCS YAG2.

The double lobe of the xray spot is a consequence of the imperfections of the surface of the xray imaging mirrors. The effect of perturbing the 120 Hz pulse train is seen in Figures 5a and b as a single trace out of the 23 overlaid projection that is slightly different from the others. This perturbation is not observable on the electron diagnostics or on the xray intensity monitors.

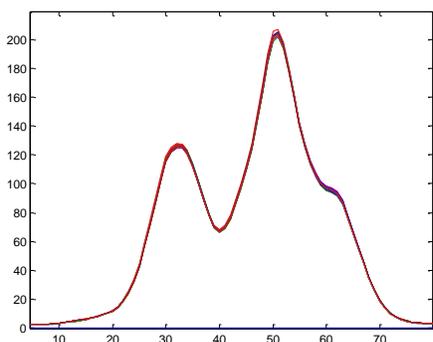
Figure 5b: Horizontal projection of XCS YAG2.

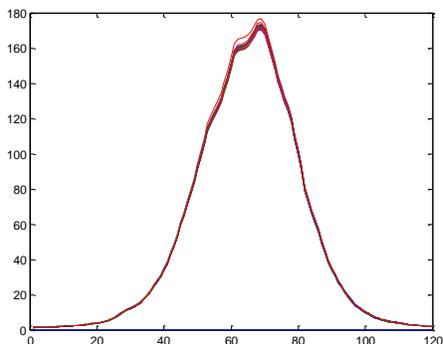
Figure 5c: Vertical projection of XCS YAG2.
