Single Pulse Damage in Copper

Contributed to the 20th International Linac Conference (Linac 2000),
8/21/2000—8/25/2000, Monterey, CA, USA

Stanford Linear Accelerator Center, Stanford University, Stanford, CA 94309

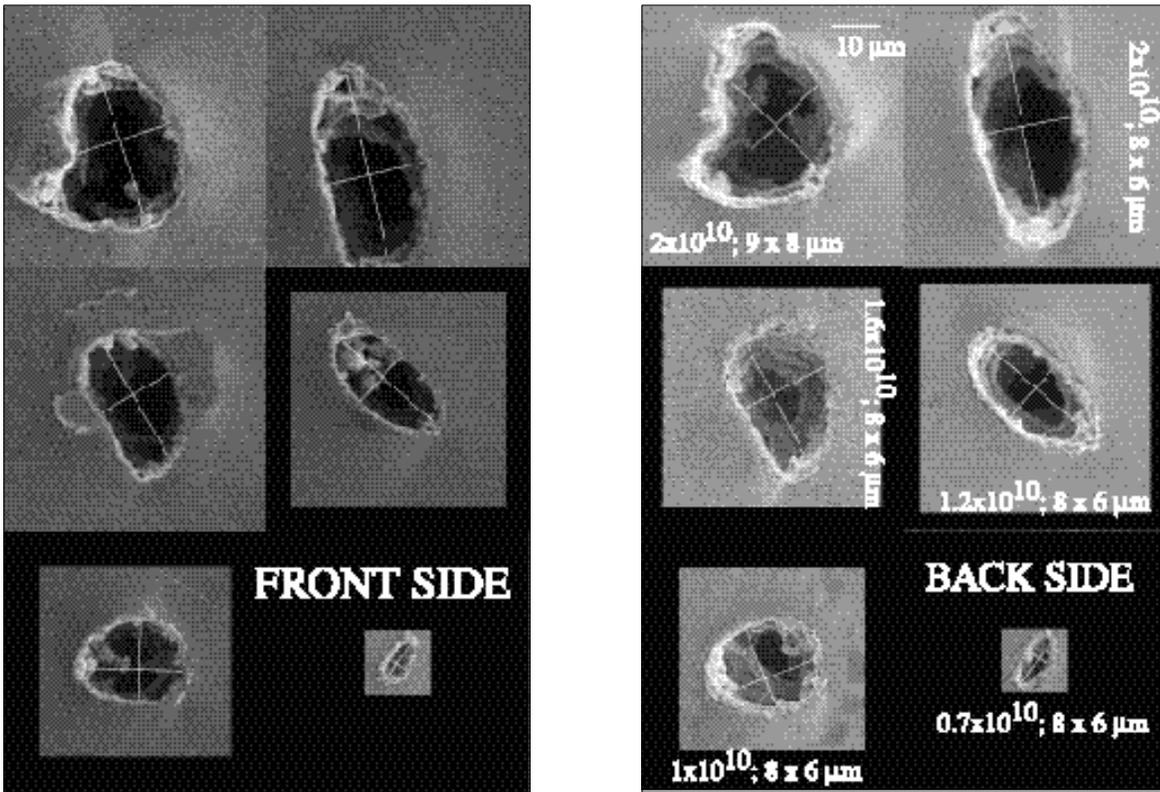
Figure 1: Scanning electron microscope (SEM) images of the entrance (left) and exit (right) points on the copper coupon. The faint lines drawn in the figure were used to estimate the impact point size. All of the images in the montage have the same scale.

Figure 1 shows the scanning electron microscope images of selected impact points (IPs), out of a total of 134 image pairs. Both the front and back side of an IP is

shown in the figure, with the images manipulated so that the spot has the same orientation.

Extreme heating followed by rapid cooling is evident from the complex surface of each IP. It also appears that some of the material is missing, leaving a substantial pit whose depth is comparable to its size. This indicates high pressure in the material along the path of the beam, with force enough to eject the liquid at the surface. We are led to conclude that some of the copper was in the gas phase, even though predictions did not indicate enough heat for full vaporization. It is possible that there is additional heat deposition from local electric currents produced by the strong field of the beam (I^2R heating), as predicted for collimator surfaces [7]. Subsequent tests using a helium based vacuum system leak detector showed small, 10^{-8} torr/liter/sec, leaks through the coupon in the region of the larger IPs.

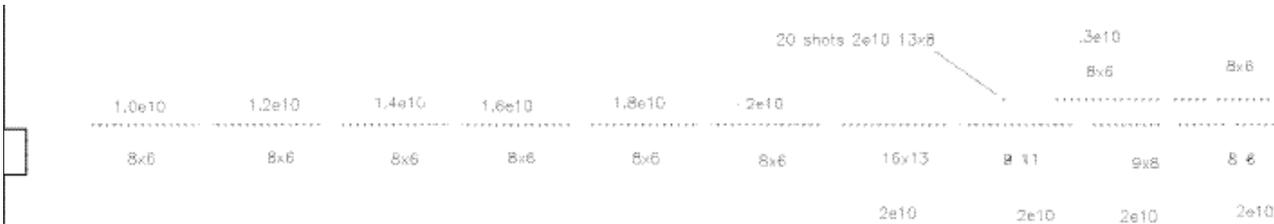
Figure 2: Sketch of a section of the copper coupon showing beam impact points (IPs) and associated parameters. The coupon size is 34 x 13 mm.

Figure 2 shows a diagram of the test coupon with the IPs. There are 12 groups of 10 (or 15) impact points spaced with 2 mm gaps. For each IP, the beam intensity and trajectory parameters were recorded. The correspondence between the IP and the beam pulse was made through examination of the pattern. The high intensity IPs, which make interesting pictures, but are not the focus of the study, allowed easy identification and enabled us to pinpoint the locations of threshold IPs, with either low intensity or large beam sizes.

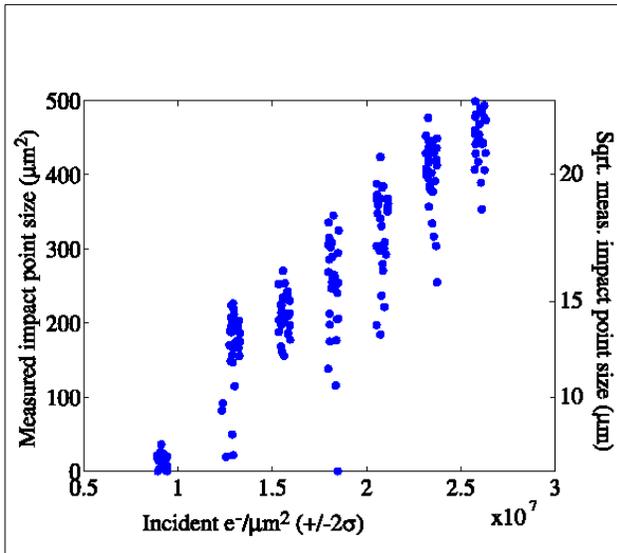
Figure 3: Measured impact point sizes vs beam density.

Figure 3 shows the measured IP sizes as a function of the incident beam density for the data set where σ_{xy} was fixed ($8 \times 6 \mu\text{m}$) and I was varied ($0.7 \times 10^{10} < I < 2 \times 10^{10}$). Linear behavior with an apparent threshold near $10^7 \text{ e}^-/\mu\text{m}^2$ can be seen in the figure. The spot size measurements were made by scaling the images along the major axis of the IP (shown as faint lines in figure 1). The major axes are usually not rotated in the beam $x y$ coordinate system.
